**High Bypass Ratio Turbine Engine
Uncontained Rotor Events**

Small Fragment Threat Characterization

Volume 2

January 2010

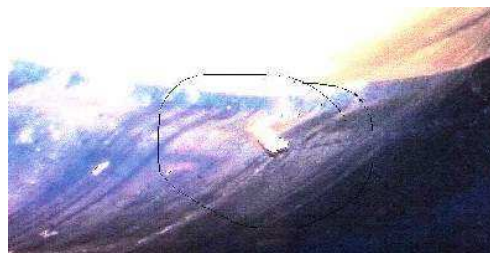
Structure hole picture

Blade stuck in skin, tip first.
Non-metallic honeycomb sandwich, fuselage
access door.
Incident angle 30-60 degrees

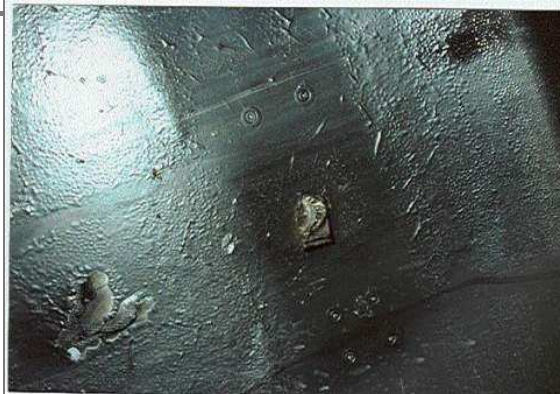
Blade stuck in skin, root first.
Non-metallic honeycomb sandwich, fuselage
access door.
Incident angle 60-90 degrees

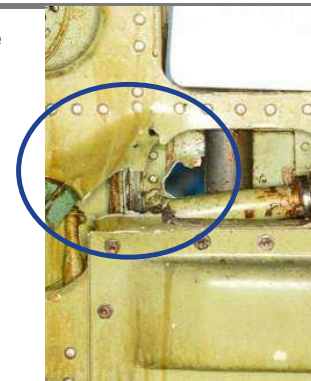
Structure picture

L4 door
0.062 Clad 2024-T3, severed locking
mechanism inside
2" x 2" hole
Incidence angle 60-90 degrees

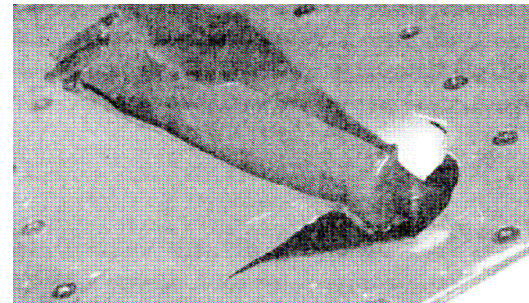
Structure picture

4.5"x1" hole

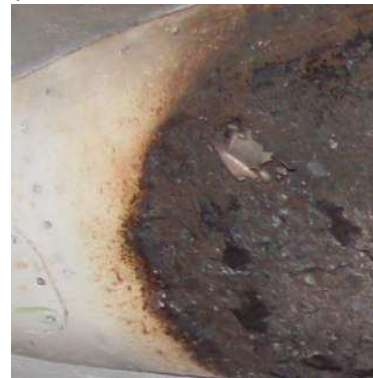
Structure picture

Blade embedded in canoe fairing

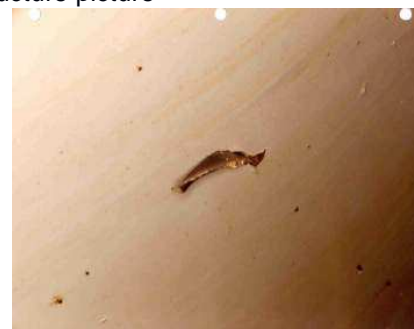
Structure picture

Fragments embedded in fuselage fairing
(non metallic honeycomb)

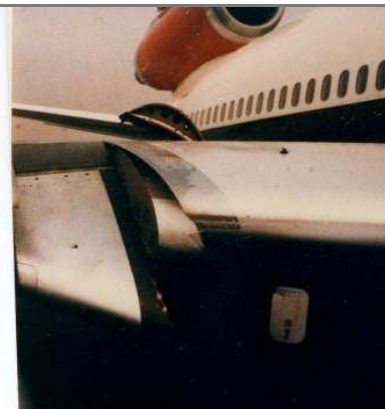
Fragment embedded in inboard leading edge
slat lower surface 0.125" Clad 7075-T6

Fragment embedded in inboard leading edge
slat upper surface 0.125" Clad 7075-T6

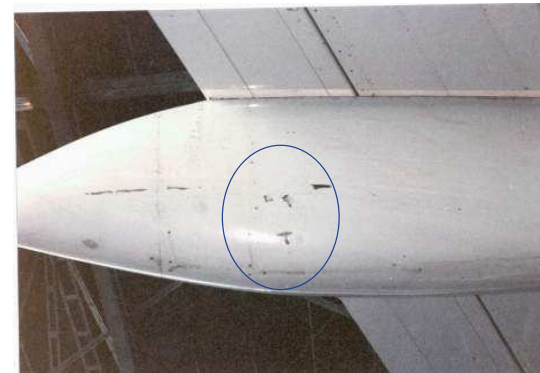
NGV platform embedded in #8 leading edge slat

Airfoil tips embedded in canoe fairings (non-metallic honeycomb sandwich)

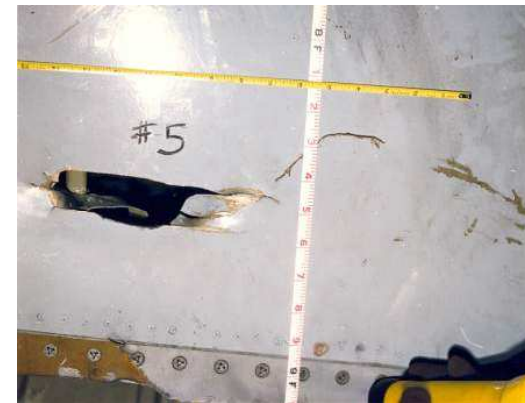
Nut found in right stabilizer torque box

Holed+ passed through 1 layer 0.020" Clad
7075-T6 leaving a 4"x1.3" hole

Shroud found in outboard left stabilizer torque
box 80" from trailing edge. Holed+ passed
through 1 layer 0.020" Clad 7075-T6 leaving
a 9"x5" hole

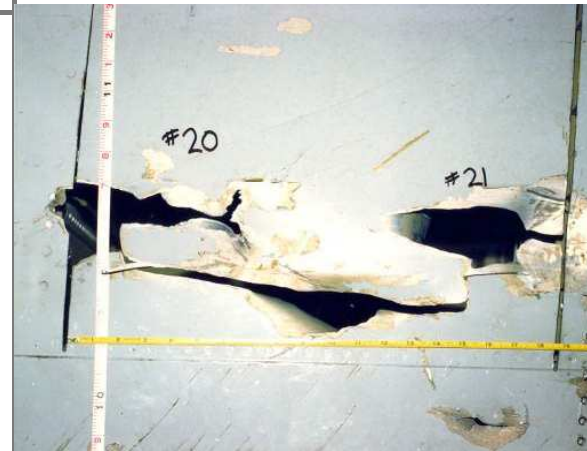
Fragments passed through a single layer of
.02 7075 leaving a 4"x2" hole

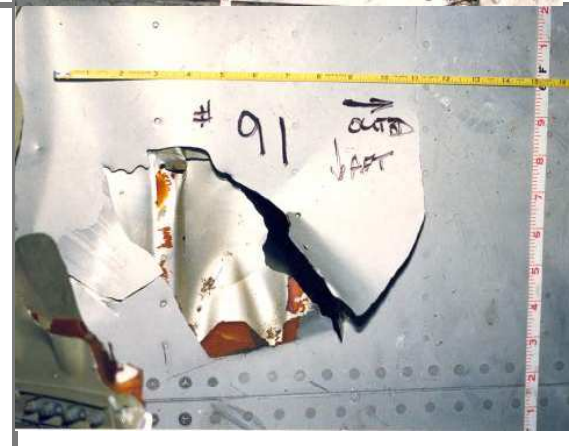
Platform Holed 2 layers of .02 7075 leaving
5"x2" hole

Booster blade holed and passed through 1
layer .02 7075 and damaged rib below (.02
7075) leaving 4"x1" hole

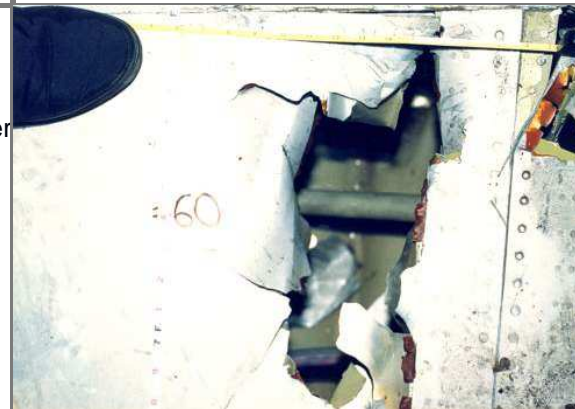
damper holed and passed through 1 layer of
.02 2024 leaving 14"x10" hole

Airfoil piece holed and passed through 1 layer
of .02 7075 leaving 4" hole

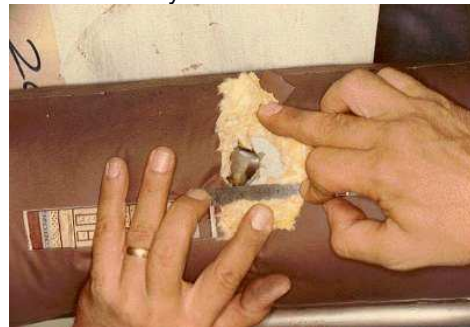
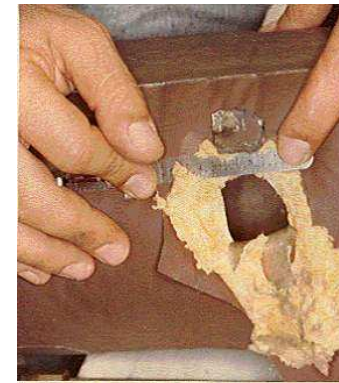
Blade holed lower fuselage skin (.09 Al), 1.5"
hole, then both walls of ECS duct, lodged in
cabin floor honeycomb sandwich

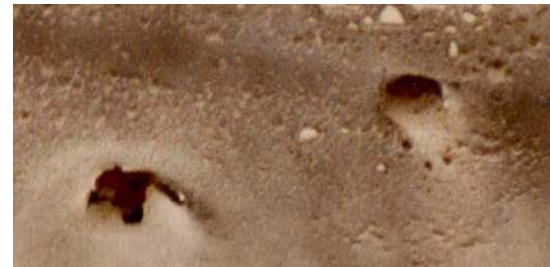
fragments holed and passed through
wingskin panel between ribs, 0.2 to 0.27" Al

Hole sizes 3x 5 cm, 4x6 cm, 10 cm

.164 lb firtree holed and passed through .19
to .26 Al wingskin

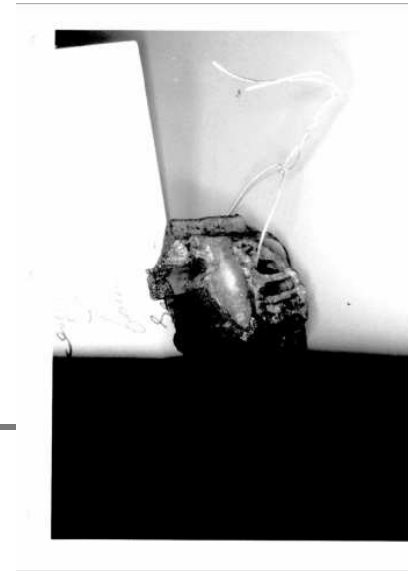
Fuselage skin holed (.09 Al), cabin floor holed
(honeycomb sandwich), piece found under
seat 27J

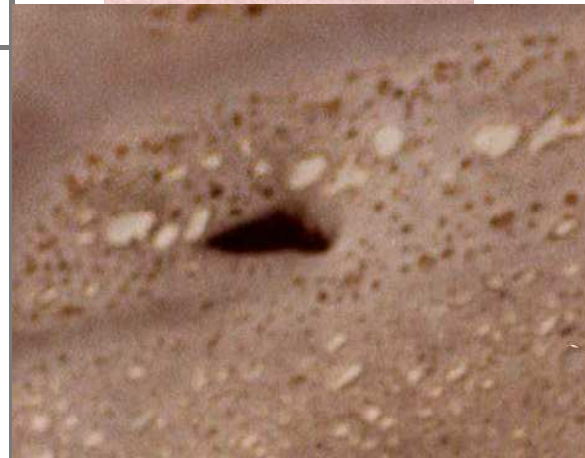
Blade embedded in cabin wall at seat 39L or
29L

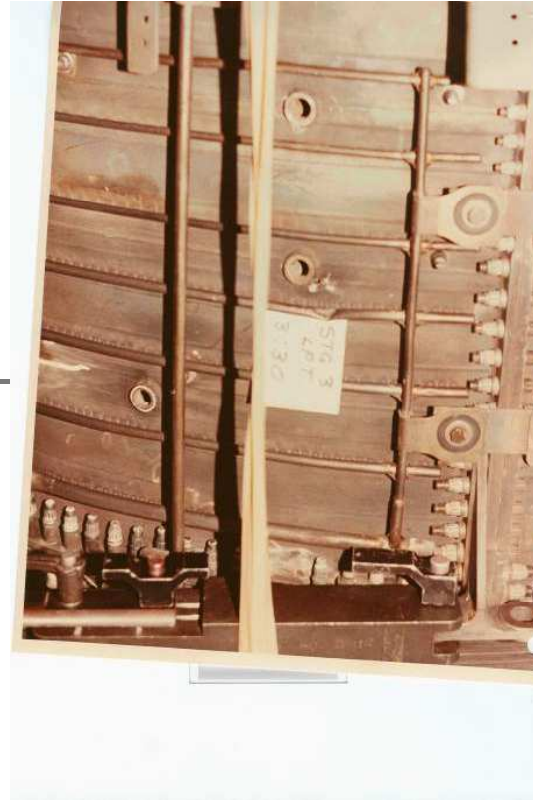
Blade passed through .04 Al core cowl
Dented .02 stainless steel tube
Holed (no passthru, 1/4" hole) LPT case .02
INCO 718

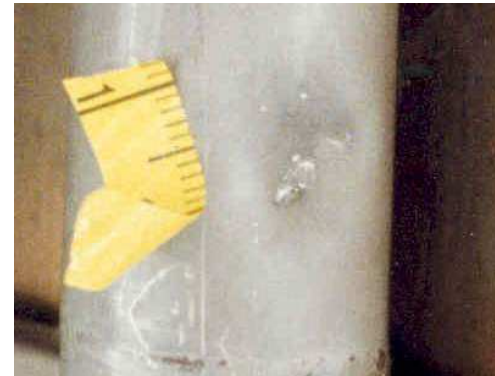
Holed opposite engine .04" Al 2024 core
cowl, hit LPT cooling manifold inside (.02
CRES), made dent with small puncture hole
(no passthrough)

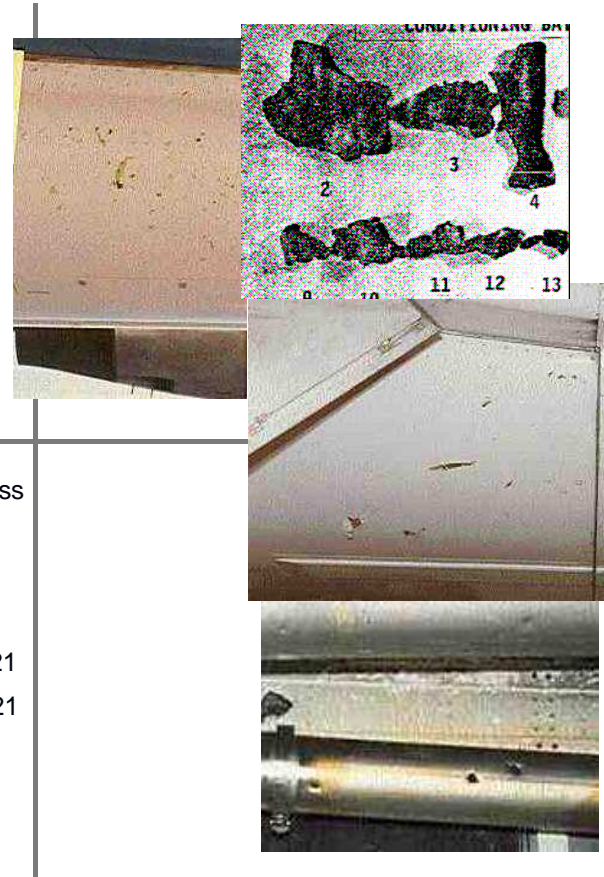
48 Pieces holed wall of packs bay (fiberglass panel) and 21 more holed wall of packs bay and underlying fiberglass ribs. They then:

- (a) Holed air conditioning valve
- (b) 3 Holed ECS duct, .028" Ti BMS 7-21
- (c) 4 Dented ECS duct 028" Ti BMS 7-21

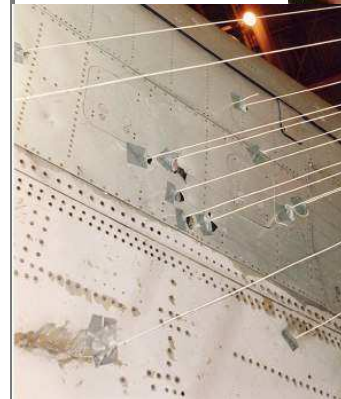
Fragment holed/ found inside in XORS 140
wing l/e .09" AI 2024
