## Introduction

Aerospace Industries Association  
AIA/EIWG Subcommittee on Engine Ground  
Operations During Heavy Snow

August 2014

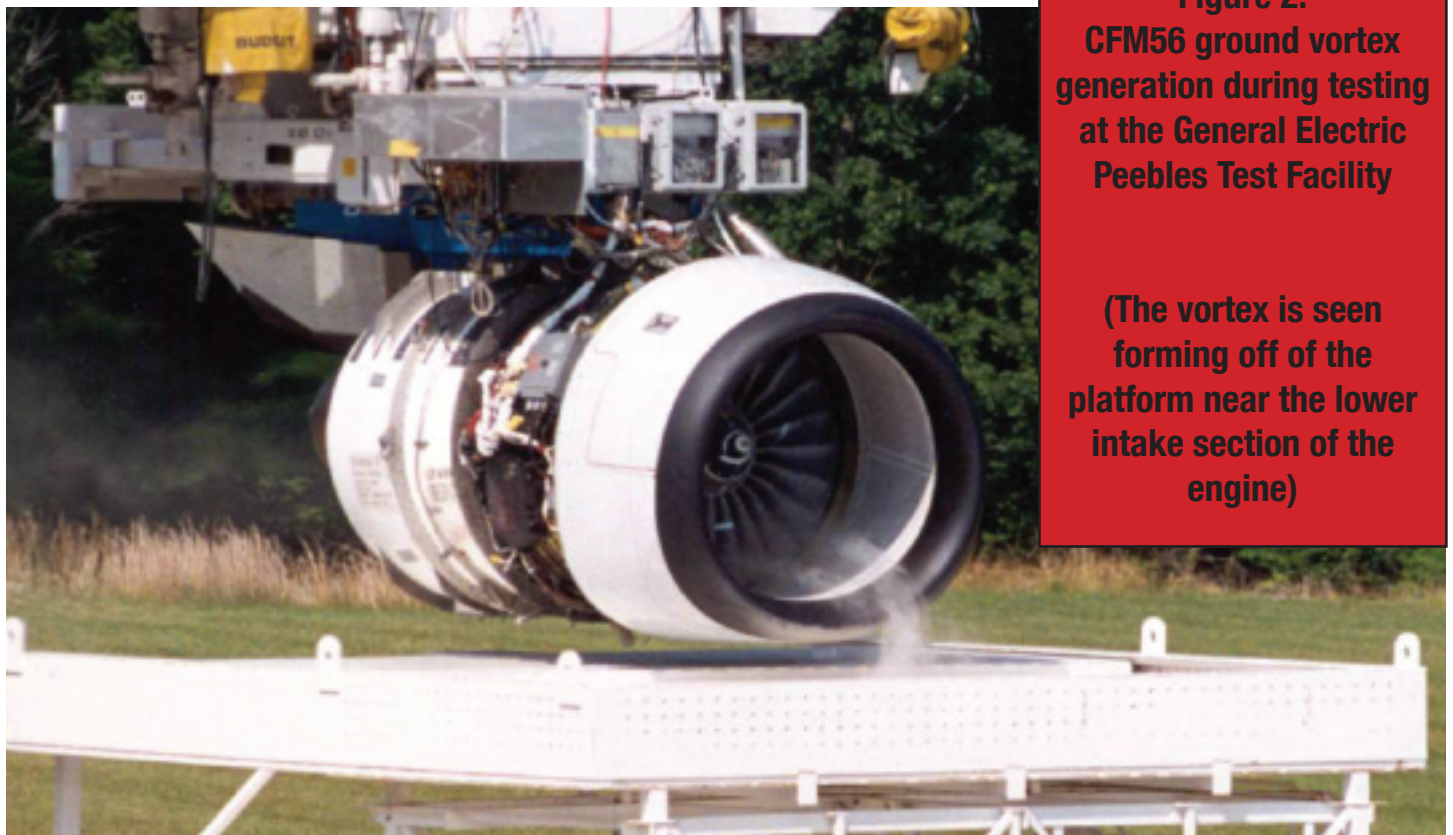
**Figure 2:**  
**CFM56 ground vortex**  
**generation during testing**  
**at the General Electric**  
**Peebles Test Facility**

The low-speed spool events resulting in fan blade damage are believed to be caused by ice accreting in the inlet barrel of the nacelle, downstream of the ice protection system extent, and upstream of the fan.<sup>29</sup> engines have incurred damage of this nature since 2007 while dispatching in snow. Fan tip damage events have occurred when visibility was less than 3/4 statute mile, and strong winds generated blowing snow. Under these conditions, the taxiways can be laden with snow and melt water that can readily be lifted into the inlet of the engine by the ground vortex, as shown in Figure 2. After review of pilot statements and photographic evidence, this subcommittee concluded that taxiway contamination was the root cause of the fan damage. The snow, water and slush was lifted off the taxiway and deposited on the inlet barrel of the engine where it solidified downstream of the ice protection system at low engine speeds; this ice was then released when power was increased. Overall time from push back was determined to be the driving factor for the phenomenon, and roughly 30 min was required for the threat to materialize for a particular engine and airframe combination.

**(The vortex is seen**  
**forming off of the**  
**platform near the lower**  
**intake section of the**  
**engine)**

- Consider having a grating beneath engines to eliminate the ground vortex responsible for lifting snow, water and diluted deicing fluid into the engine
