**High Bypass Ratio Turbine Engine
Uncontained Rotor Events**

Small Fragment Threat Characterization

Volume 2

January 2010

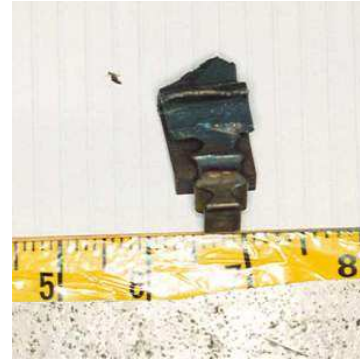
Fragment picture

Event 2000C
Mass estimate 0.24 lbs,
Dimensions 1" x 1" x 1.5",
LPT1 blade firtree and platform
Tangential speed at burst 888 ft/s

L4 door
0.062 Clad 2024-T3, severed locking
mechanism inside
2" x 2" hole
Incidence angle 60-90 degrees

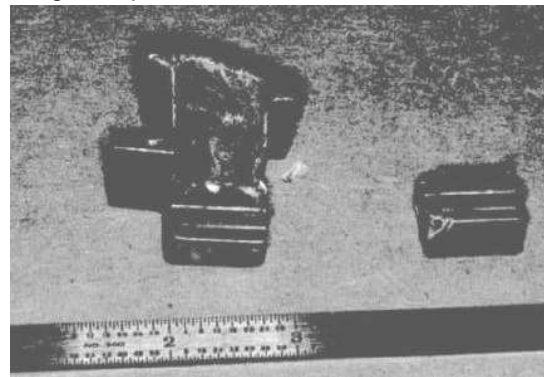
Fragment picture

Event 2000C
Mass estimate 0.4 lbs,
1" x1" x1.5", LPT4 blade firtree
Tangential speed at burst 888 ft/s

L/e flap
Firtree embedded in non metallic honeycomb
sandwich
Incidence angle 60-90 degrees

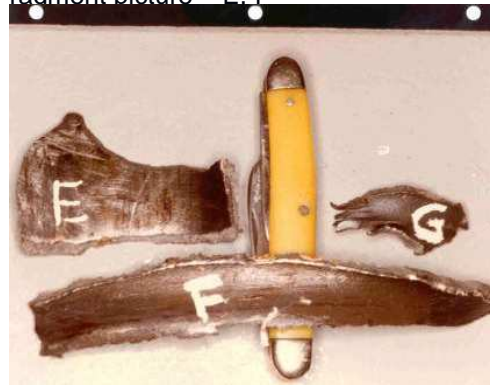
Fragment picture – E, F

Disk web fragments 5 oz and 2.5 oz,
Dimensions 1.3"x 9" x0.3" and 4" x 2" x .25"
Tangential speed at burst 830 ft/s

Fragments embedded in fuselage fairing
(non metallic honeycomb)

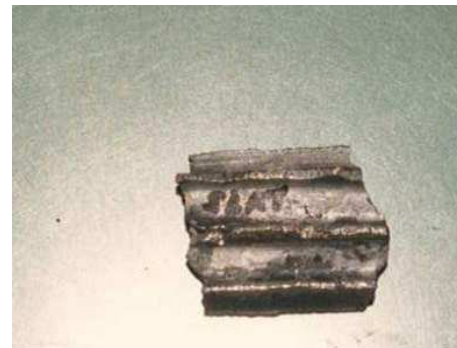
Fragment picture

Fragment embedded in inboard leading edge
slat lower surface 0.125" Clad 7075-T6

Fragment embedded in inboard leading edge
slat upper surface 0.125" Clad 7075-T6

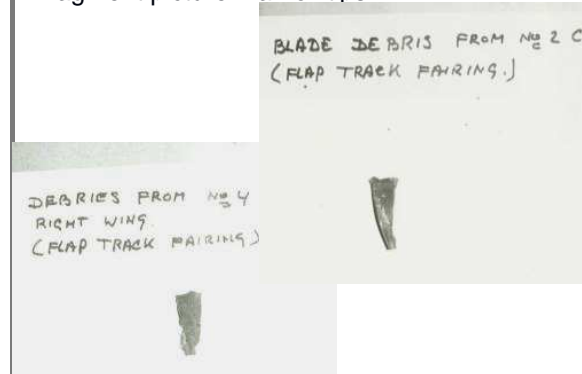
Fragment picture – airfoil tips

NGV platform embedded in #8 leading edge slat

Airfoil tips embedded in canoe fairings (non-metallic honeycomb sandwich)

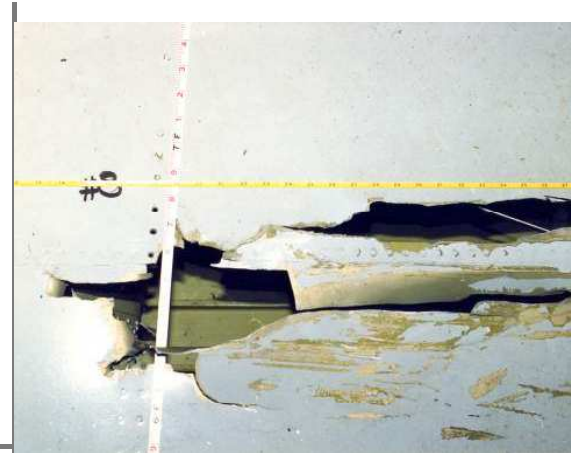
Fan stub shaft nut, 1/2" diameter, 2 oz incident
at 15 degrees (hole 5)

Nut found in right stabilizer torque box

Holed+ passed through 1 layer 0.020" Clad
7075-T6 leaving a 4"x1.3" hole

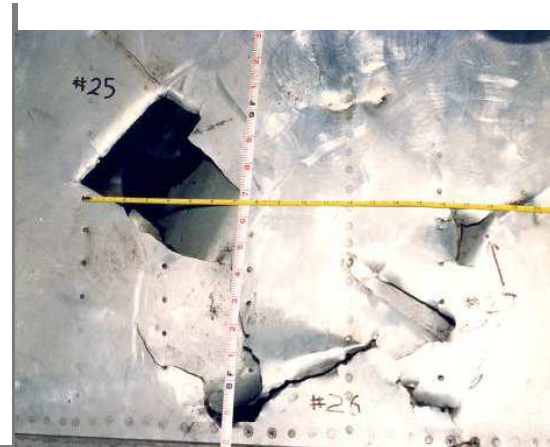
Booster blade, 5 oz, incident at 45 degrees
hole 91

Platform Holed 2 layers of .02 7075 leaving
5"x2" hole

Booster blade holed and passed through 1
layer .02 7075 and damaged rib below (.02
7075) leaving 4"x1" hole

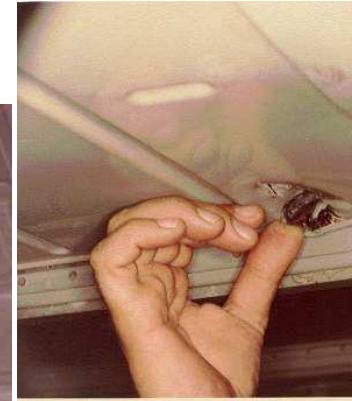
Event 1981B
HPT2 blade fragment, 1" x.75", 1.5 oz
Tangential speed at burst 1070 ft/s, incident
angle 40 degrees

Blade holed lower fuselage skin (.09 Al), 1.5"
hole, then both walls of ECS duct, lodged in
cabin floor honeycomb sandwich

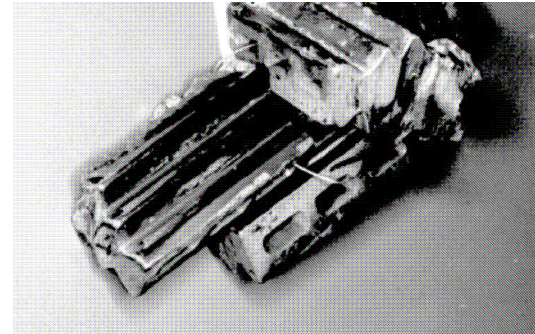
fragments holed and passed through
wingskin panel between ribs, 0.2 to 0.27" Al

Hole sizes 3x 5 cm, 4x6 cm, 10 cm

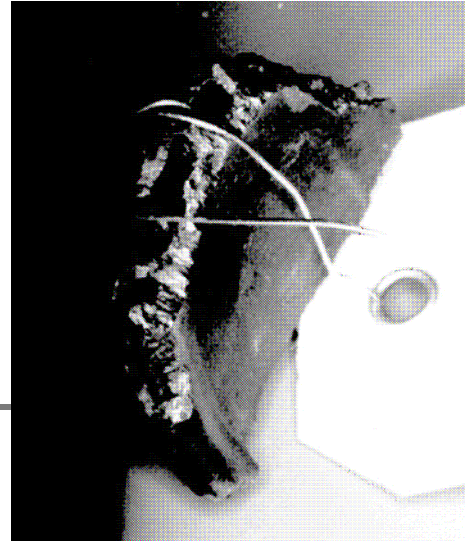
Event 1982A
Airfoil fragment, estimate .07 lb, 1.8" x .5"
Tangential speed at burst 1105 ft/s

Blade embedded in #6 flap

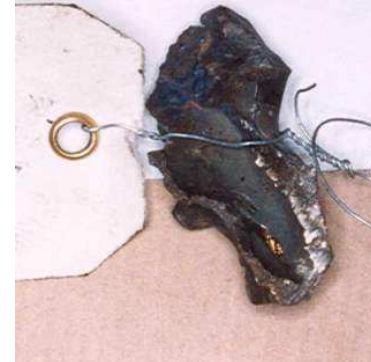
HPT airfoil piece $\frac{1}{2}$ " x $\frac{1}{2}$ ", .035 lb

Blade embedded in cabin wall at seat 39L or
29L

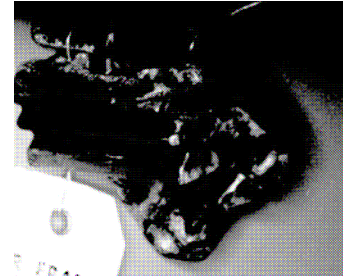
Fragment picture

Fragments found in air conditioning CA2

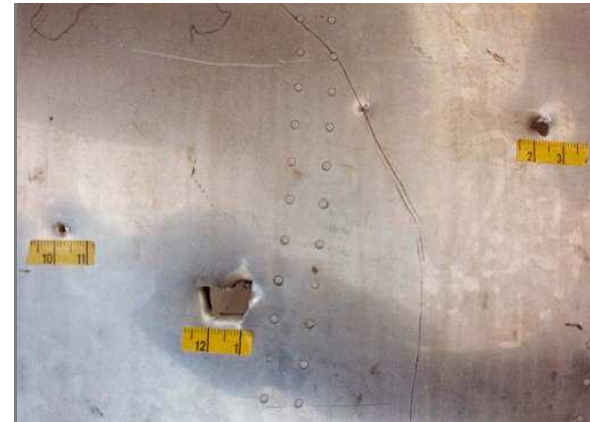
Event 1991
.07 oz fragment HPT
Tangential speed at burst 1030 ft/s
Incident angle 60-90

Holed opposite engine .04" Al 2024 core
cowl, hit LPT cooling manifold inside (.02
CRES), made dent with small puncture hole
(no passthrough)

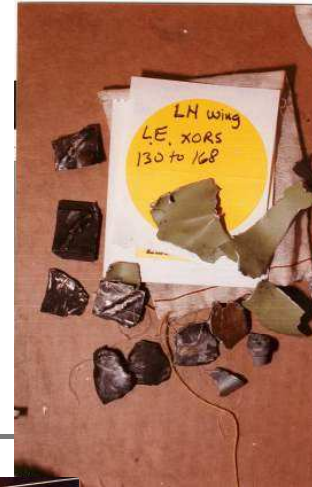
Event 1992
0.64 oz HPC vane platform,
Tangential speed at burst 1000 ft/s

Fragment holed/ found inside in XORS 140
wing l/e .09" AI 2024
