## Introduction

Aerospace Industries Association  
AIA/EIWG Subcommittee on Engine Ground  
Operations During Heavy Snow

August 2014

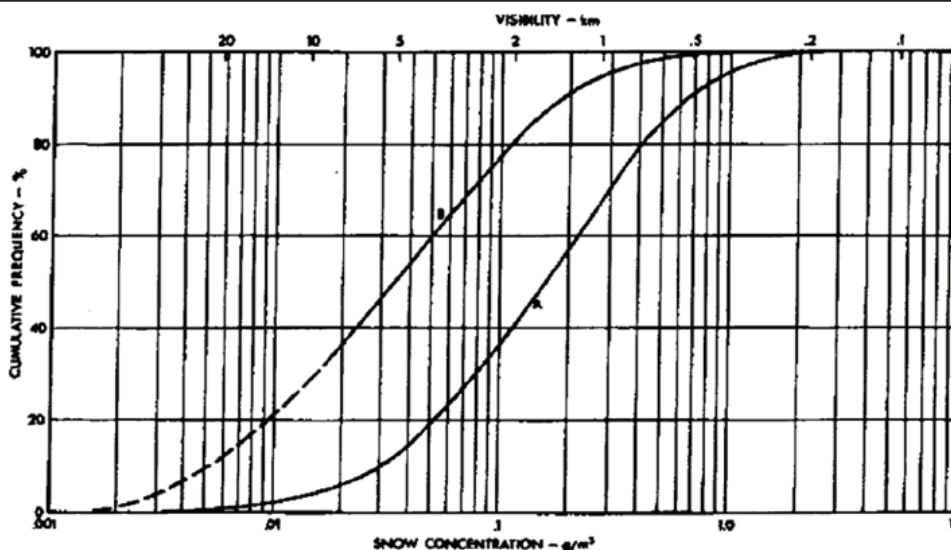
**Figure A.**  
**Reference 1**  
**Data on Snow**  
**Concentration**

Figure A, below, is a reproduction of Figure 12 from [3]. It includes two curves indicating cumulative probability of snow concentrations calculated from two data sets of observed visibility observations. Curve A is based on the same data set used to derive the correlation, and indicates that the probability is about 94% that snow concentration will not exceed 0.91 g/m<sup>3</sup>. Curve B is based on a larger multiyear data set, and indicates that the probability is greater than 99% that snow concentration will not exceed 0.91 g/m<sup>3</sup>.

**FIG. 12 CUMULATIVE FREQUENCY OF SNOW CONCENTRATION FOR OTTAWA**

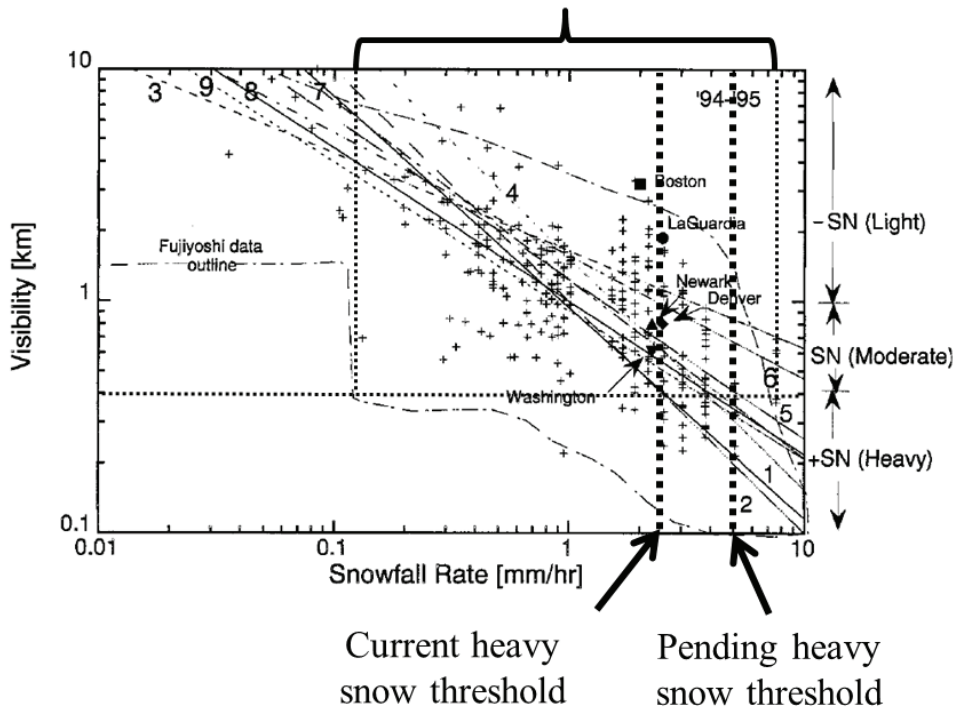
Range of snowfall rates possible using 1/4 statute mile visibility as the boundary between moderate and heavy snowfall

**Figure 1:**  
Range of snowfall rates possible using 1/4 statute mile visibility as the boundary between moderate and heavy snowfall
