# **AIA Powerplant Indications Task Team Report**

## Executive Summary

The AIA Powerplant Indications Task Team was formed July 2001 in response to the FAA draft Harmonization Terms of Reference (HTOR) 25.1305. The team was subsequently sanctioned by the AIA as the Powerplant Indications Task Team. The team includes representation from several Airframe Manufacturers, Engine Manufacturers and Regulatory Agencies. The AIA PITT was an active working group from late 2001 through mid-2006. After 2006 the team gradually prepared a team report via ad hoc team telecons. The team has provided:

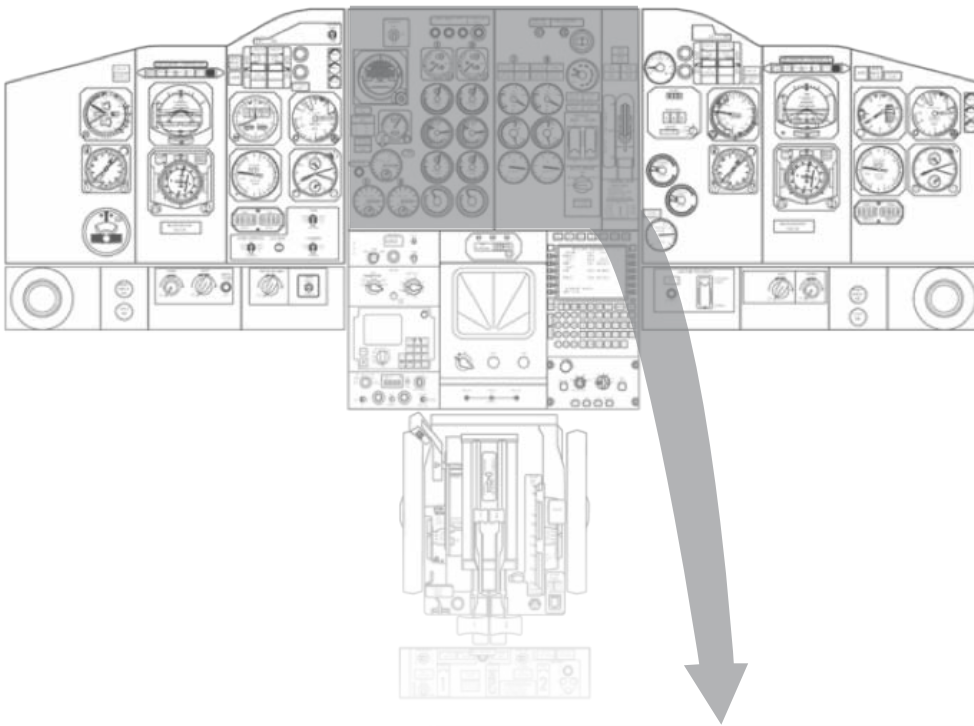
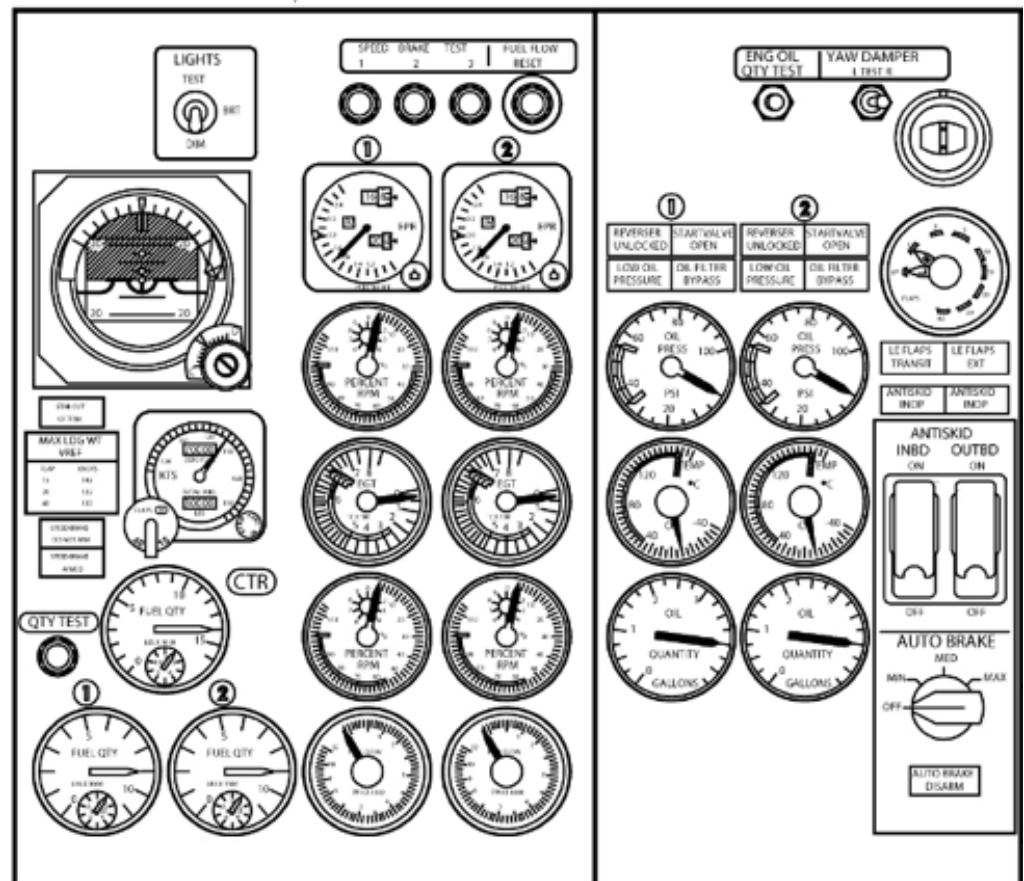
**Figure 1** Example of prior generation (pre-glass cockpit, circa 1968) flight deck powerplant indications - Boeing 737-200 with Pratt & Whitney JT8D engine.

- Existing Powerplant regulations were based on mechanical 'instruments' (Figure 1) while modern systems typically provide powerplant indications on electronic displays (Figure 2). The electronic display guidance material was initially created when early generation displays were under development, before the capability and good reliability of these systems was understood.

| Old paragigm | New pardigm |
|---|---|
| See figure 1 and 2 for examples of old vs. new paradigm | |

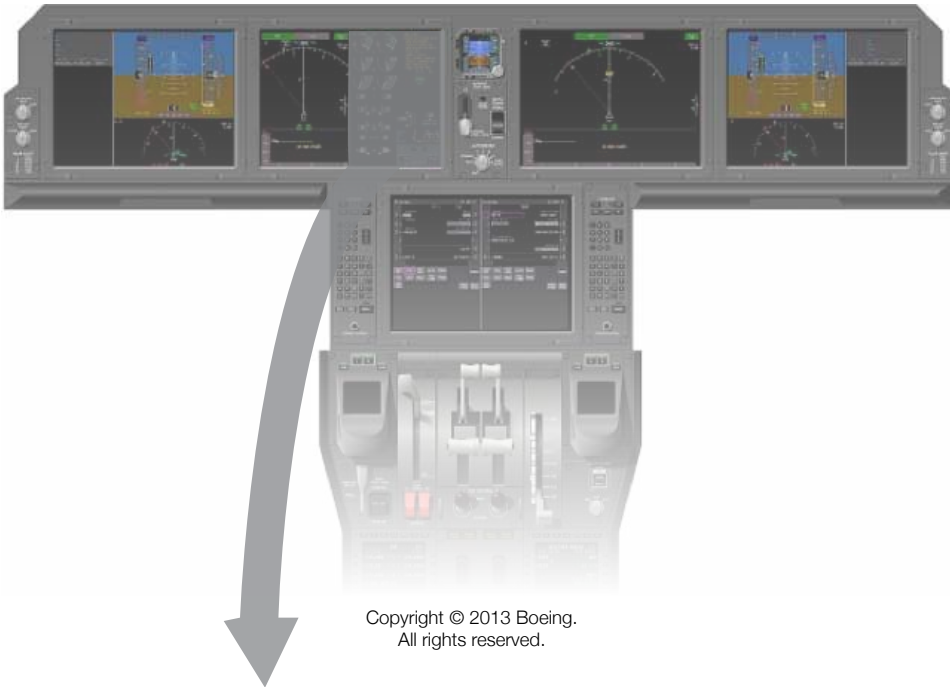
**Figure 2** Example of current generation (circa 2012) flight deck powerplant indications - Boeing 787-8 with General Electric GEnx engine. During normal operation, typically only the primary parameters are displayed (see lower left).. The primary + secondary parameters (see lower right) may be displayed either manually by flightcrew selection or automatically under specific normal and non-normal operation conditions where secondary engine parameters are needed.

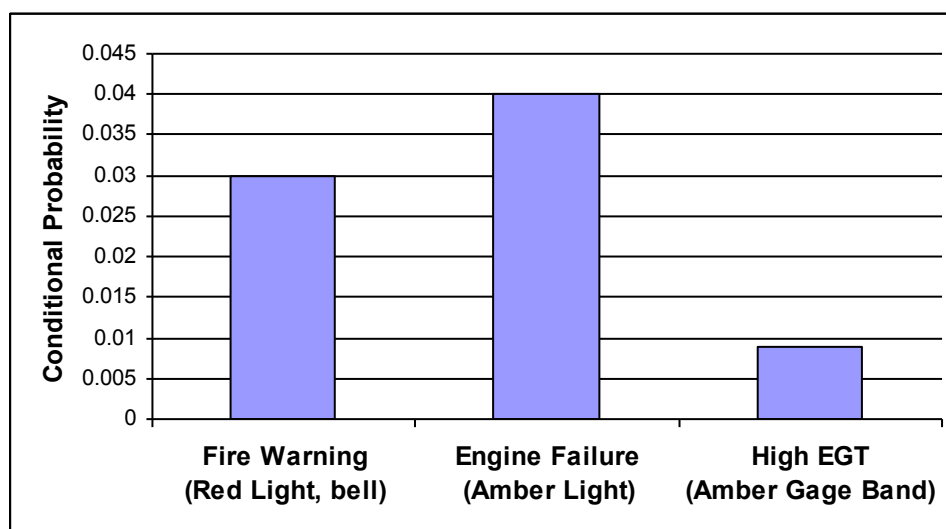
**Figure 1.** Probability of RTO above V1, given a symptom.

<sup>6</sup> This study was conducted on the GE/CFMI High Bypass Turbofan fleet between 1975-1996. This material was original presented to the AIA /AECMA PSM+ICR group during their Atlanta meeting.

<sup>7</sup> For the period of study 1975-1996, the great majority of the fleet did not have the takeoff phase alerting inhibit features standard on more recently designed aircraft
