# Continued Airworthiness Assessment Methodology: Lessons Learned

GERMANI, M (BOEING COMMERCIAL AIRPLANES)  
KNIFE, SARAH (GE AVIATION)

# Report

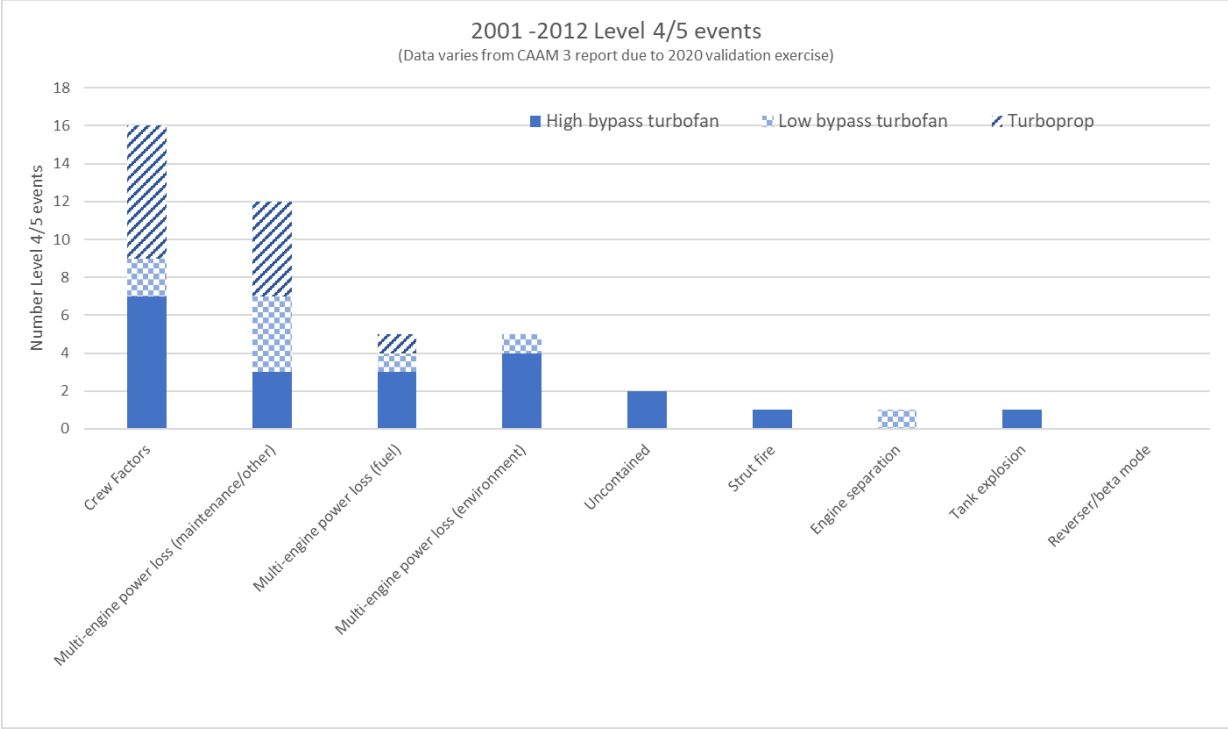
Figure 2 Event causal factors

The greatest contribution to level 4/5 events (fatality/ serious injury, hull loss, complete sustained power loss in flight) was crew factors; either crew incorrect operation of the propulsion system, or difficulties in recognizing a propulsion system malfunction and responding in accordance with standard procedures. Other key contributions were multi-engine power loss due to maintenance or other operational factors, due to fuel exhaustion or contamination, or due to environmental causes. It should be noted that the multi-engine power loss events did not always result in hull loss or fatalities.

Engine uncontained release of high energy fragments, fires, engine separation and tank explosion were smaller contributors.

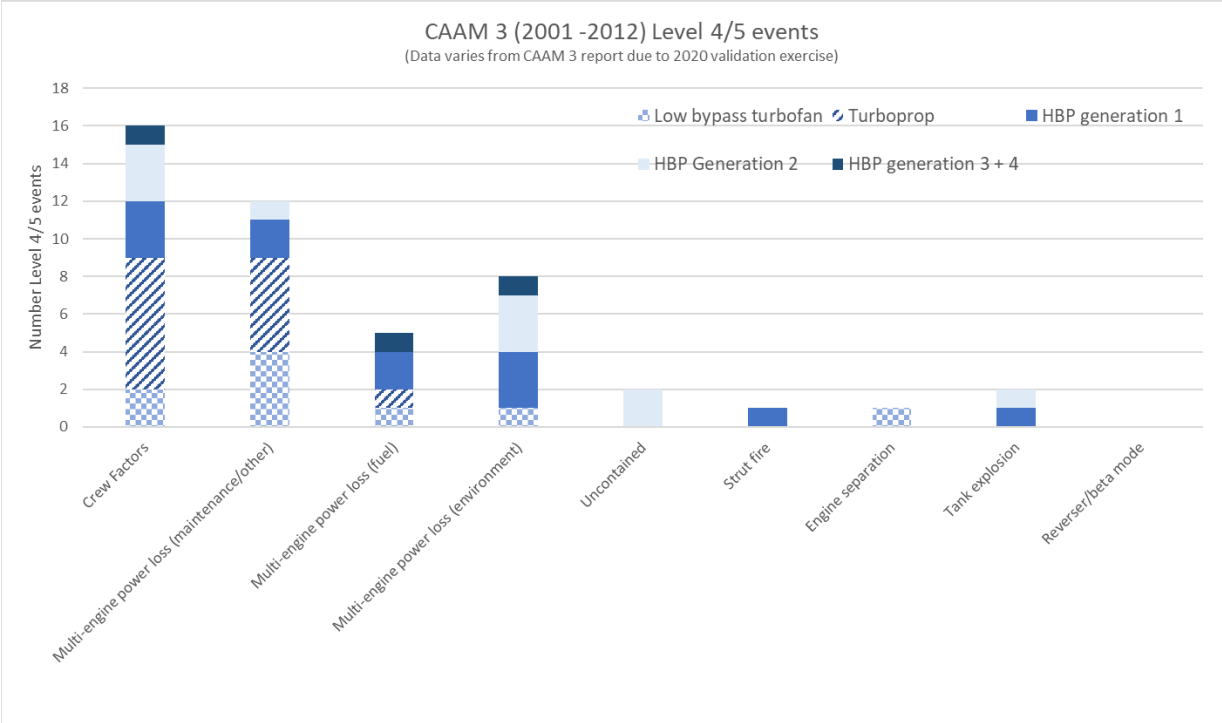
Figure 3 Distribution of events by generation

The 1<sup>st</sup> Generation High Bypass Ratio (HBPR) engines were designed in the mid-late 1960’s and early 1970’s. These engines were the successors to the Low Bypass Ratio (LBPR) architecture and installations that had their origins in the 1950’s and 1960’s. As the 1<sup>st</sup> Generation HBPR engines have matured in service the original operators of this equipment have modernized with newer 2nd/3rd/4th generation HBPR powered airplanes. These 1<sup>st</sup> Generation HBPR engines have continued in service, but have now changed ownership (in many instances multiple times) from the original operators that utilized the equipment.

The HBPR 1<sup>st</sup> Generation CAAM level 4/5 events are not product specific, but rather the majority can be addressed by corrective actions that are broader in scope such as Maintenance awareness, Crew training, etc. This is also the case with the low bypass fleet. A parallel can be drawn between the fleet utilization of the low bypass and the high bypass generation 1 fleets, as low bypass equipment goes out of service and is replaced by generation 1 high bypass products. At this point in the life cycle, the HBPR 1<sup>st</sup> Generation and LBPR fleets should be treated similarly with respect to the recommended corrective actions and methods to deploy those to help further retire risk from the fleet.

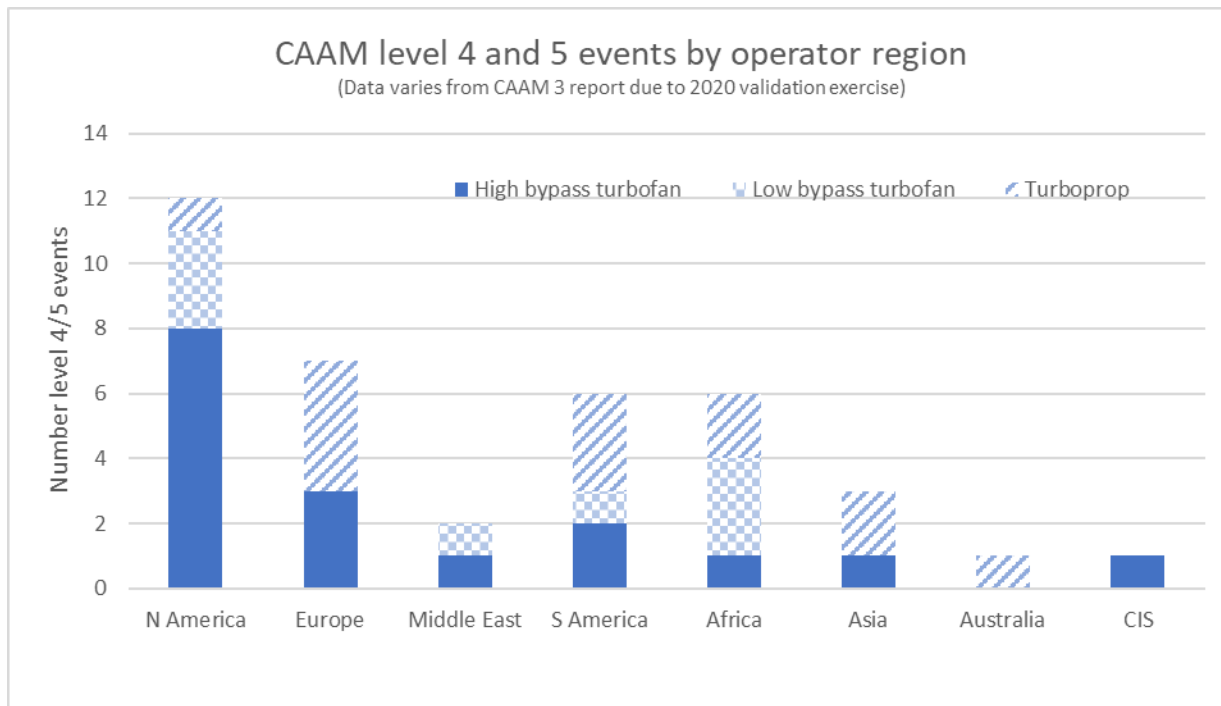
Figure 7 Regional distribution of events

Stratifying the data by region provided no clear insights; the result is provided in Figure 7 for completeness.

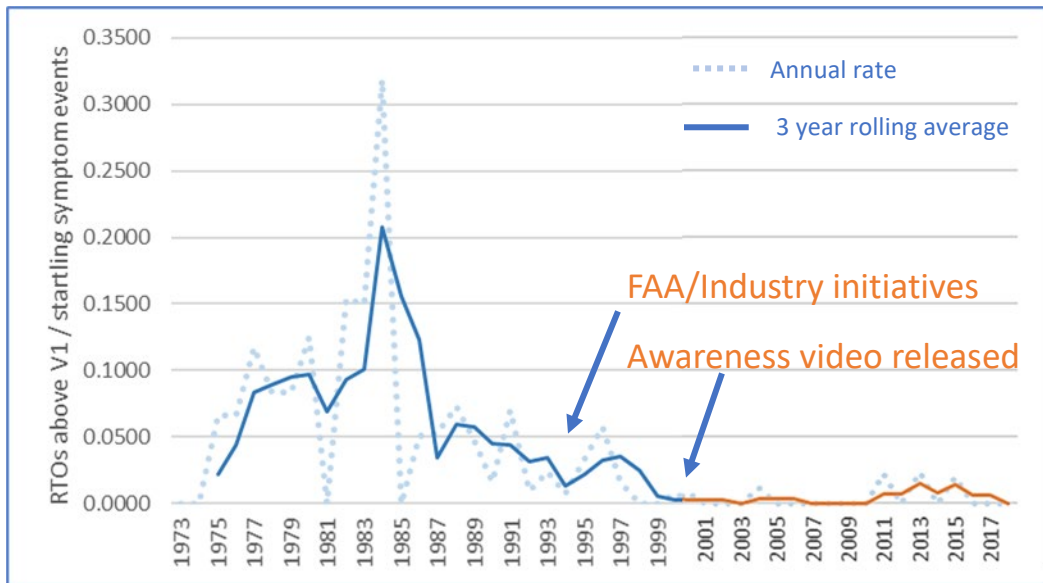
Data on rejected takeoffs above V1, caused by engine symptoms, was collected for the high bypass turbofan fleet of a major manufacturer, from 1973 to 2018.

The trend in Figure alpha is consistent with these 1990s FAA/ industry initiatives, including the propulsion malfunction awareness package, having had a positive effect, which reduced over time as the awareness of the flight crew was diluted (retirements and introduction of new flight crew).

The propulsion malfunction awareness package, and similar initiatives in the mid/late 1990s, may likely have contributed to the observed reduction in crew inappropriate response. More recent data (2010 on) shows a small upward trend in the metric, consistent with reduced awareness of the package. Refreshed awareness of the package may be beneficial.
